SYMPTOM	PROBLEM	SOLUTION
<p><b>It is difficult to fill the Mudrunner</b></p>

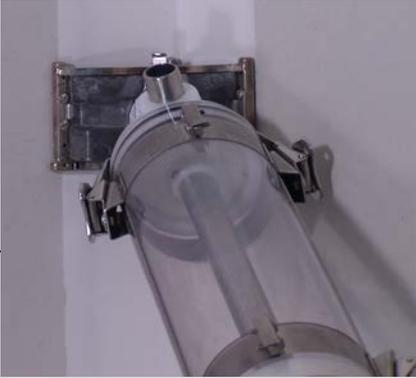
<p><b>Joint Compound doesn't flow fast enough; have to move Mudrunner very slowly to achieve good finish (DSC 1541-Sherri)</b></p>

<p>Joint compound is too thick and will not flow thru the Mudrunner</p>

<p>Mix joint compound with approximately 28 to 32 oz. of water per 5 gallons of joint compound. Check manufacturer for recommended amounts of water that can be added to joint compound.</p>
